Special Report 76-11

OBSERVATIONS
ALONG THE PIPELINE HAUL ROAD
BETWEEN
LIVENGOOD AND THE YUKON RIVER

R. Berg and N. Smith

October 1976

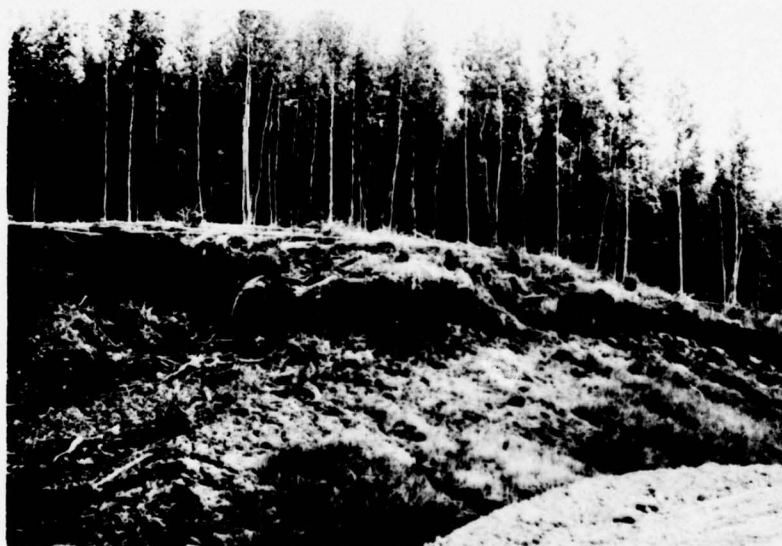
11. Thawing near top of slope; start of grasses,
Mile 4.5 Rt, 11 August 1970.

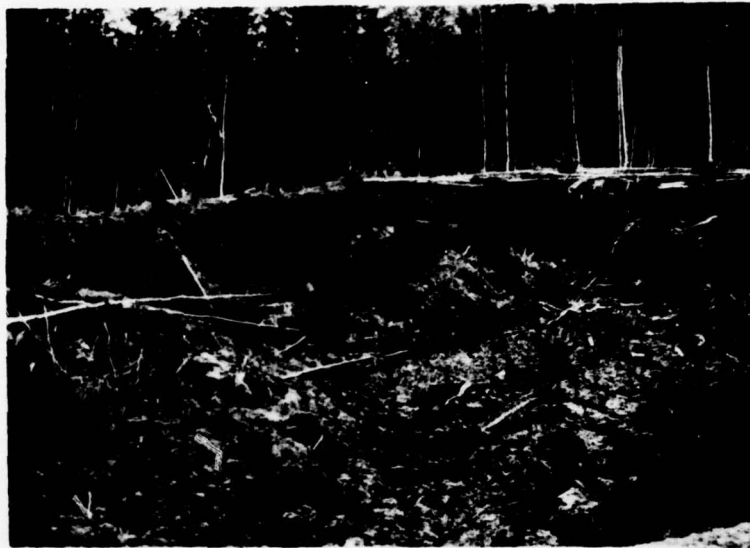
12. Most active thawing, Mile 4.5 Rt, 11 August 1970.

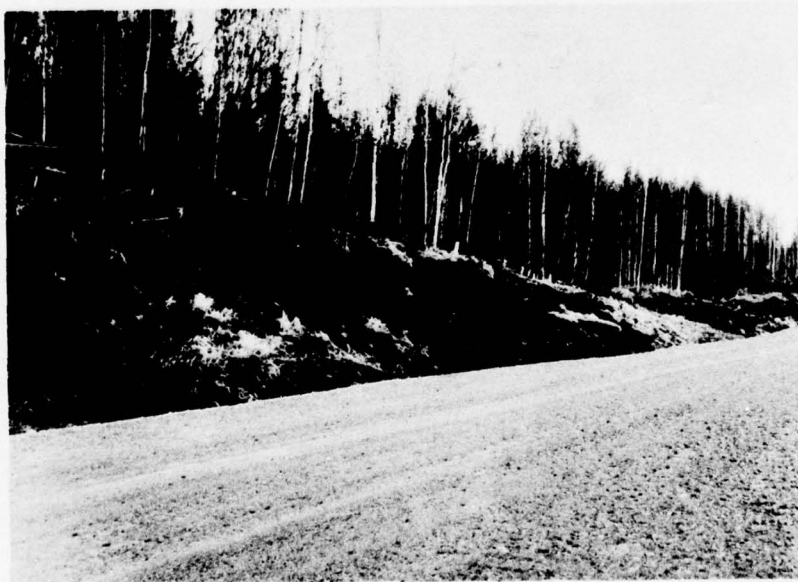
13. Southern end of receding and seeded backslope, Mile 4.5 Rt, 27 May 1971.

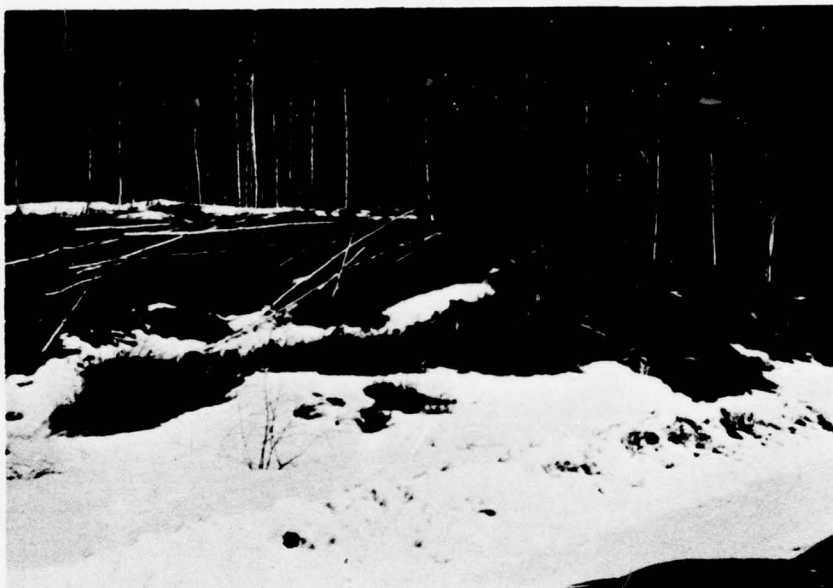
16. Southern end of backslope, Mile 4.5 Rt,
20 April 1973.

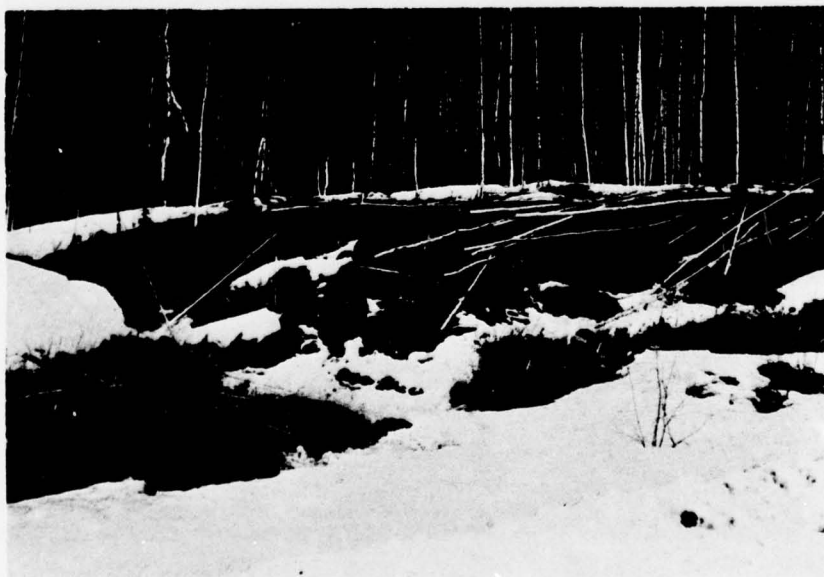
17. Center of partially snow-covered slope, Mile 4.5 Rt,
20 April 1973.

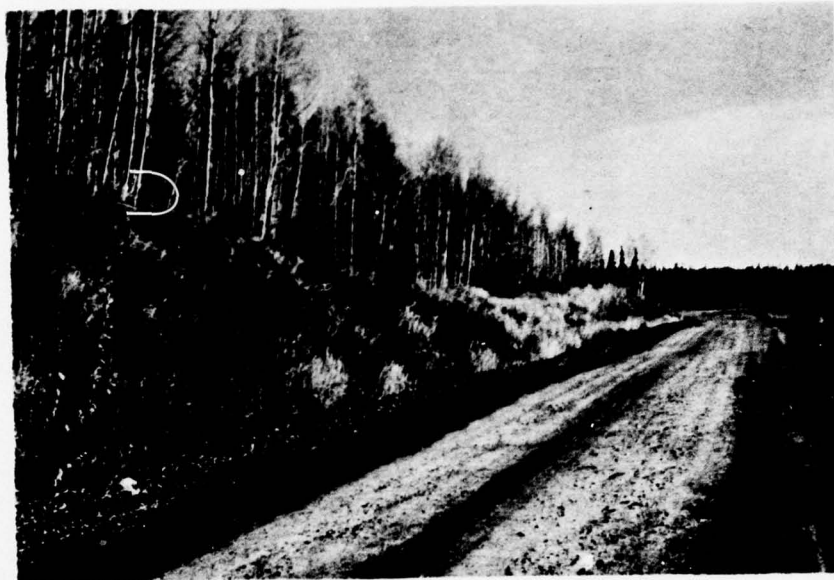
18. Southern end of backslope, Mile 4.5 Rt,
27 September 1974.

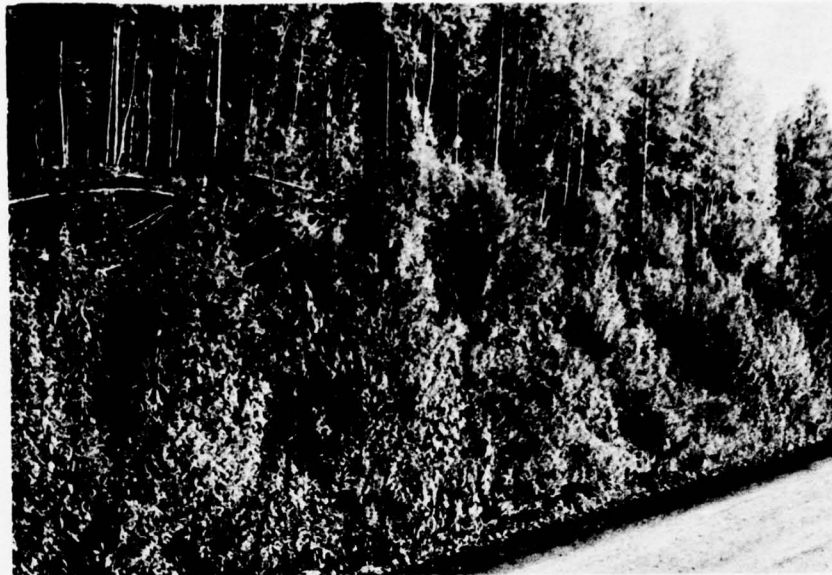
20. Southern end of backslope, Mile 4.5 Rt,
14 September 1975.

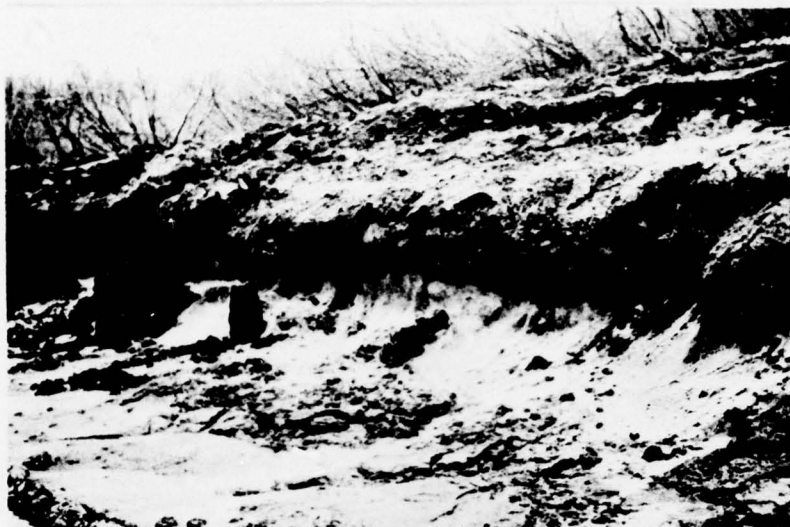
There are actually two slopes involved here, both facing in a southwesterly direction. Figures 22 and 23 illustrate a large mass of ice visible in a shallow cut on 23 April 1970. Figure 24 shows the slope on 11 August 1970. A good growth of grasses had started where the slope was not rapidly degrading. A gravel berm had been placed near the toe of the slope to allow drainage of excess water and to partially

22. Massive ice in shallow cut, Mile 9.85 Rt,
23 April 1970.

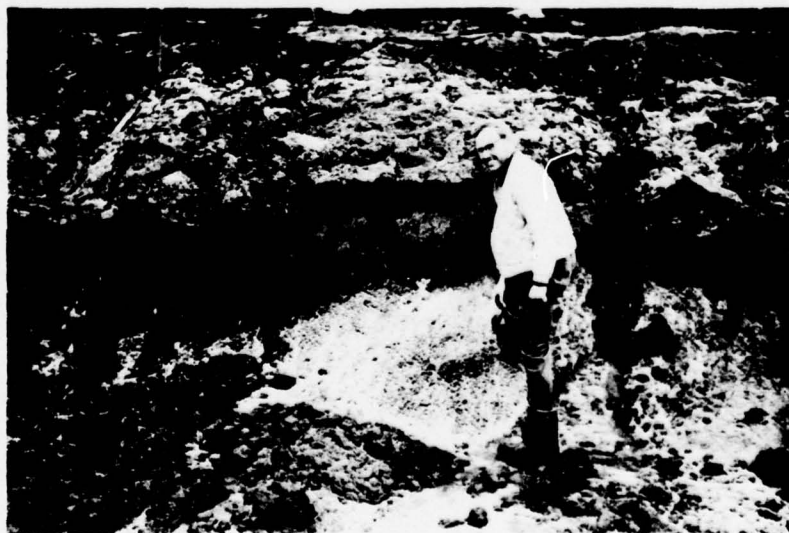
23. Close-up of massive ice in shallow cut,
Mile 9.85 Rt, 23 April 1970.

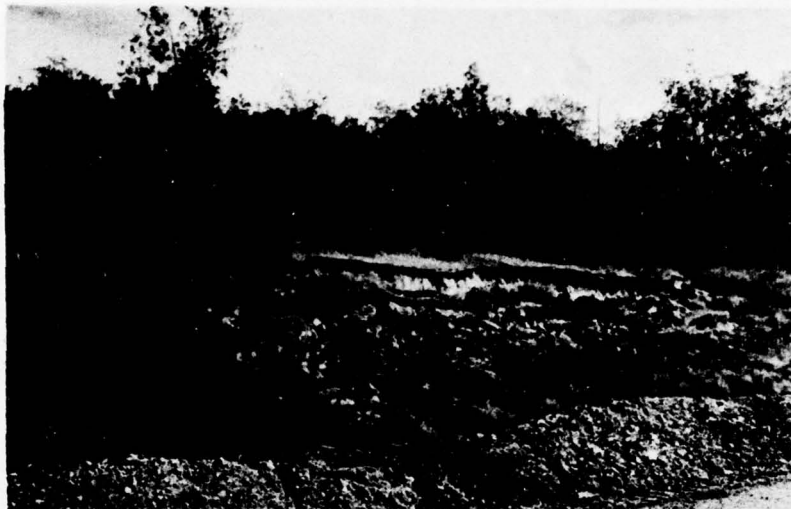
24. Thawing shallow backslope with grass and gravel berm,
Mile 9.85 Rt, 11 Aug 1970.

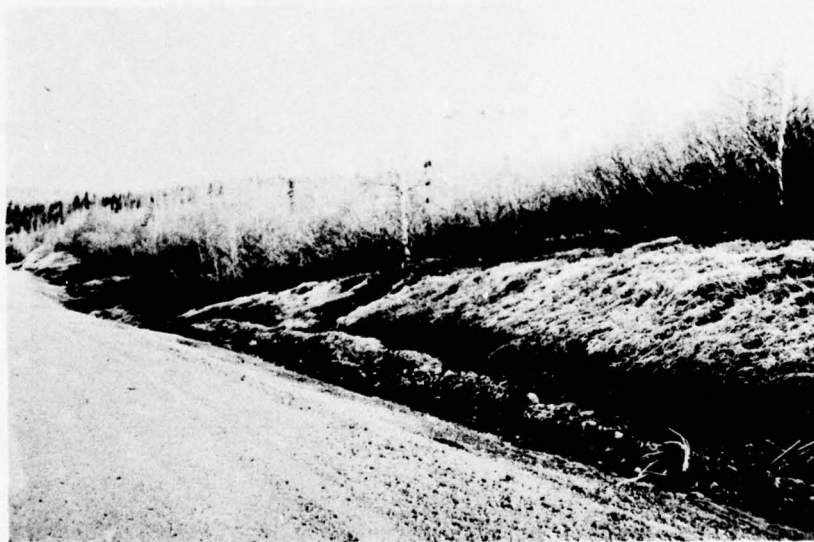
restrain the mineral soil as it fell from the receding ice. On 28 May 1971 the berm was easily observed (Fig. 25 and 26). Most of the slope appeared relatively stable but a small part continued to degrade rapidly (Fig. 26). Figure 27, taken on 27 September 1974, shows the same area as Figure 24 and represents a nearly stable condition on the shallow slope.

The second slope at this site developed stability problems during the second thaw season. It can be seen at the extreme left in Figure 25. It is much higher but the ice-rich soil was not exposed during construction. The photographs taken on 17 August 1971, Figures 28 and 29, show the massive movement and the disruption of the relatively heavy grass cover caused by subsurface thawing. The slope looked quite stable in September 1974 when last photographed. The grass cover had rehealed and some small trees had started to grow (Fig. 30).

25. Relatively stabilized shallow cut,
Mile 9.85 Rt, 28 May 1971.

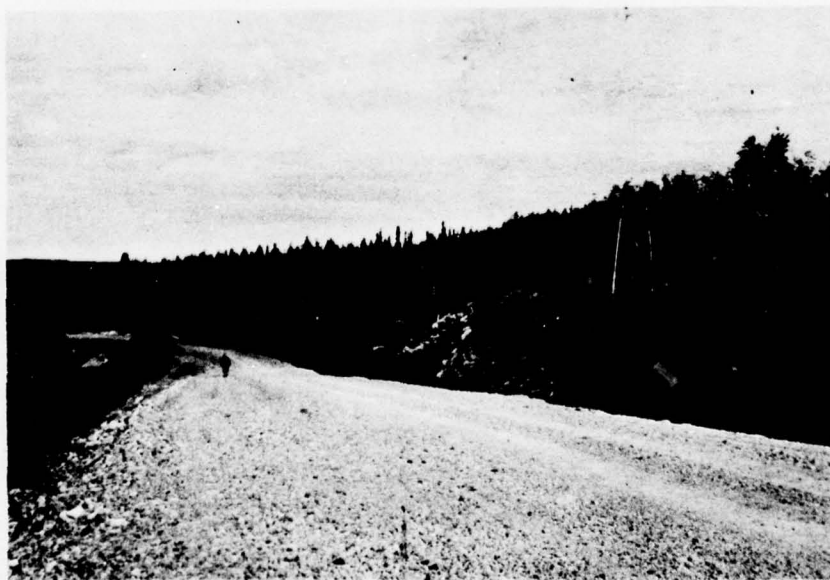
29. Overall view of deep cut, Mile 9.85 Rt, 17 August 1971.

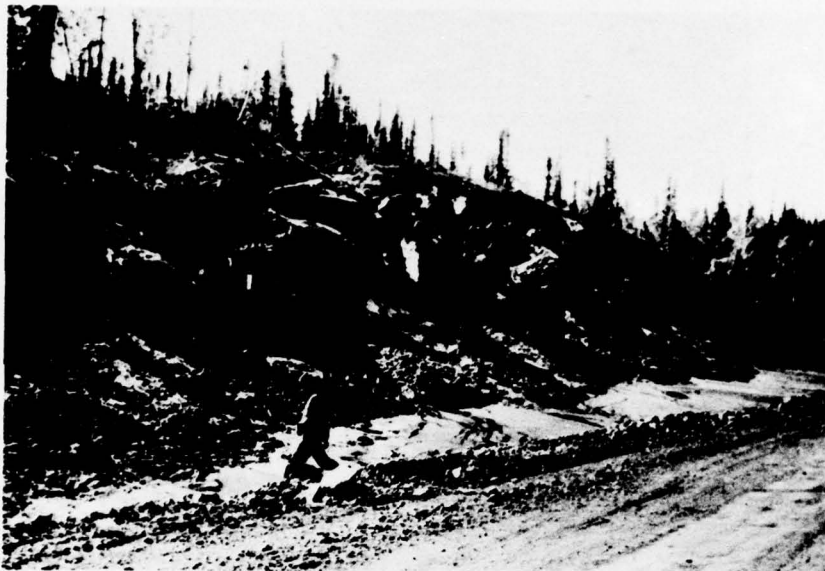
32. Thawing backslope, Mile 19.6 Lf, 26 June 1970.

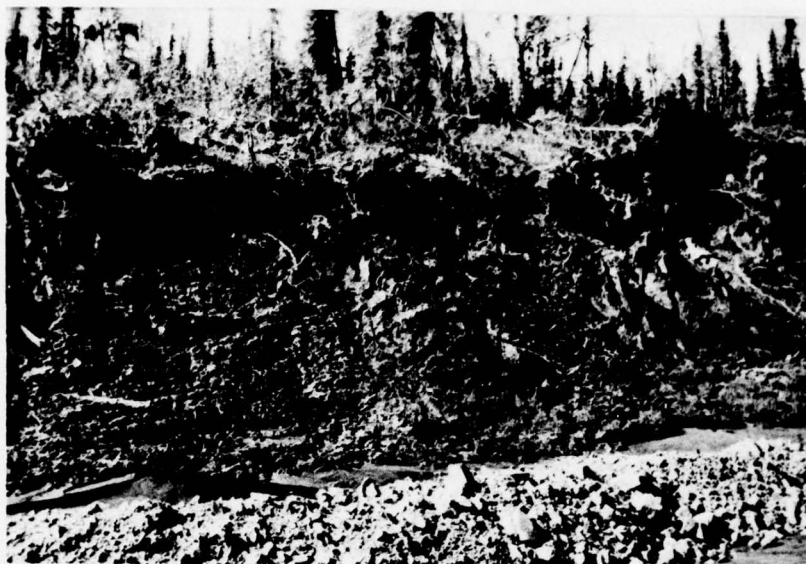
36. Mud flow on thawing backslope, Mile 19.6 Lf,
11 August 1970.

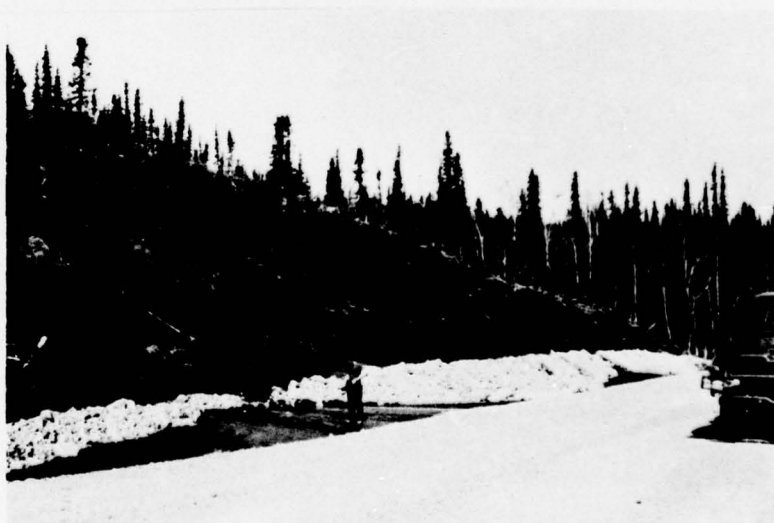
37. Receding backslope and stabilized ditch sediments,
Mile 19.6 Lf, 23 May 1971.

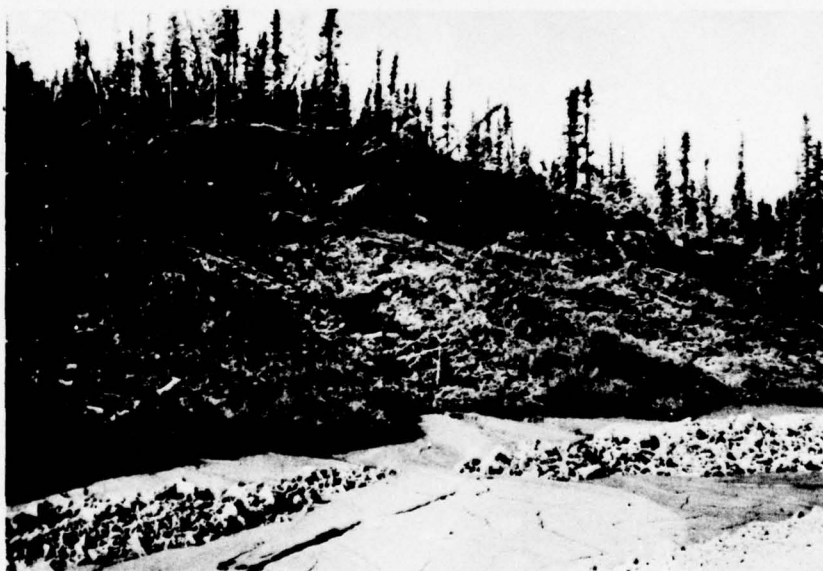
39. Overall view of slope showing desiccation of ditch
sediments and continued slope recession, Mile 19.6 Lf,
17 August 1971.

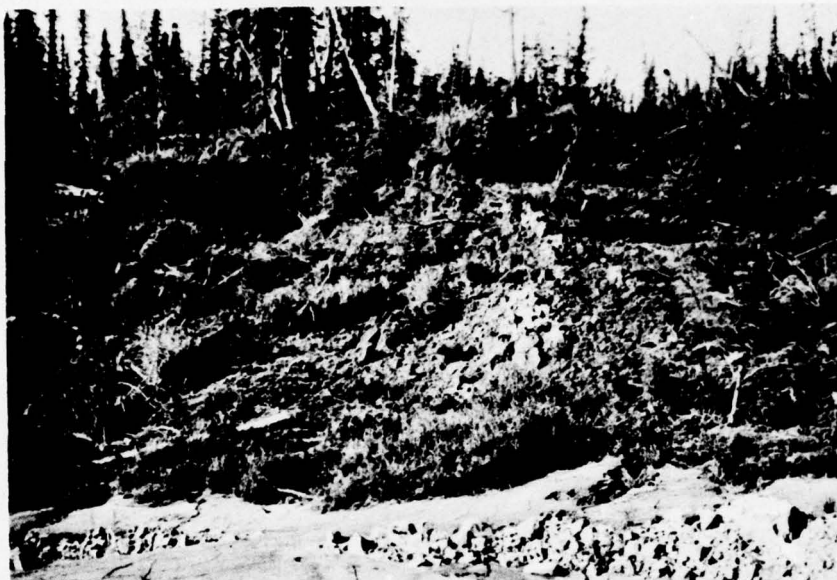
42. Grasses growing higher up the slope, Mile 19.6 Lf, 23 June 1972.

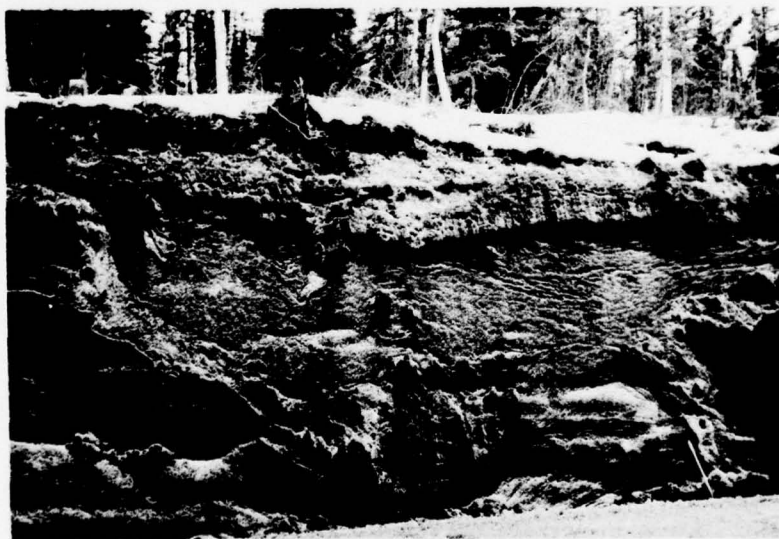
This slope faces the northeast. Figure 45 shows a large mass of ice in the cut on 23 April 1970. This slope degraded rapidly and by September 1970 a shot rock revetment had been installed in the ditch

45. Massive ice in frozen backslope, Mile 19.9 Lf,
23 April 1970.

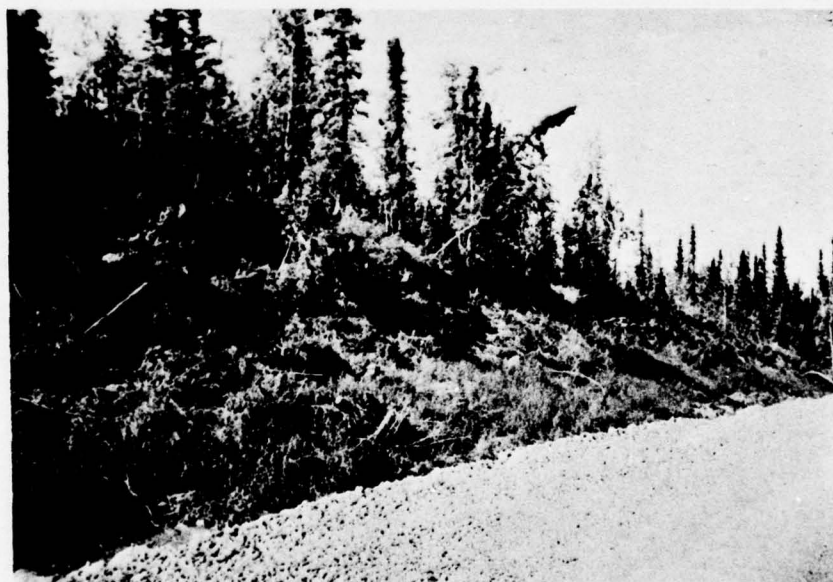
49. Overall view of backslope, Mile 19.9 Lf, 17 August 1971.

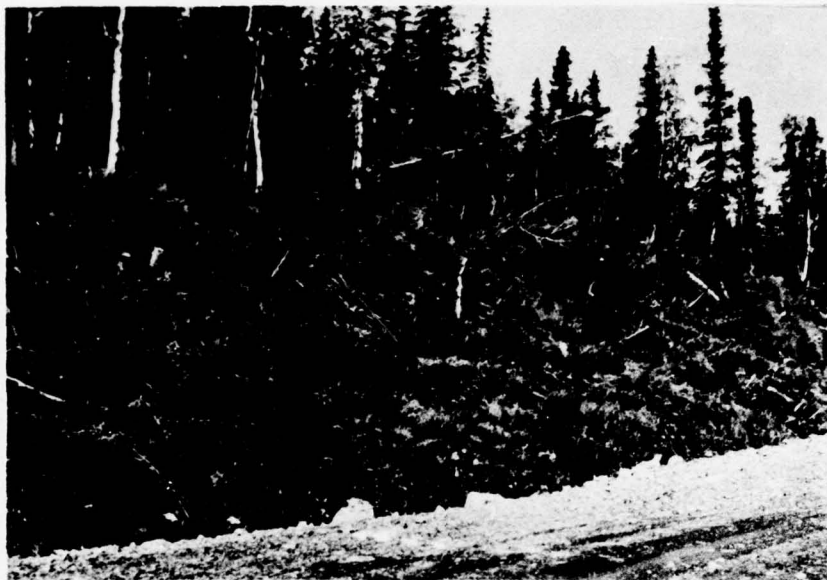
50. Overall view of backslope, Mile 19.9 Lf, 23 June 1972.

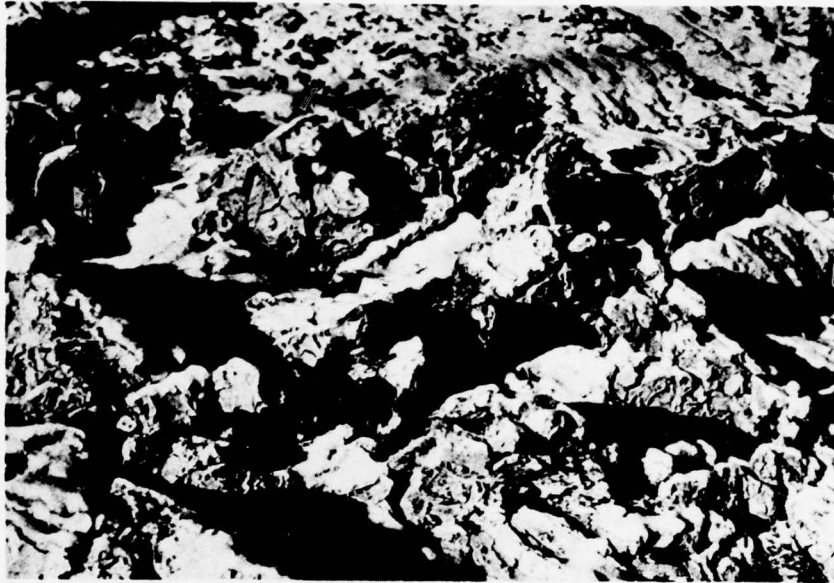
52. Close-up of insulation, Mile 19.9 Lf, 27 September 1974.

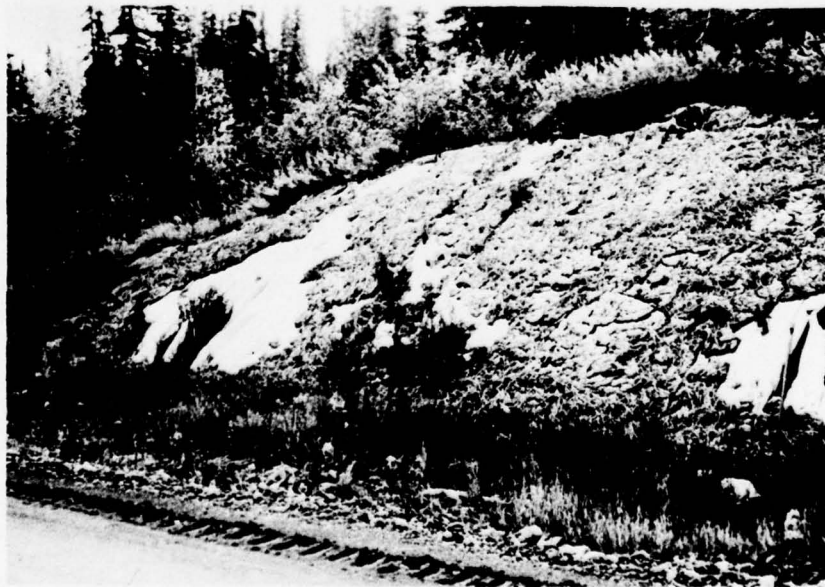
53. Insulated backslope, Mile 19.9 Lf, 14 September 1975.

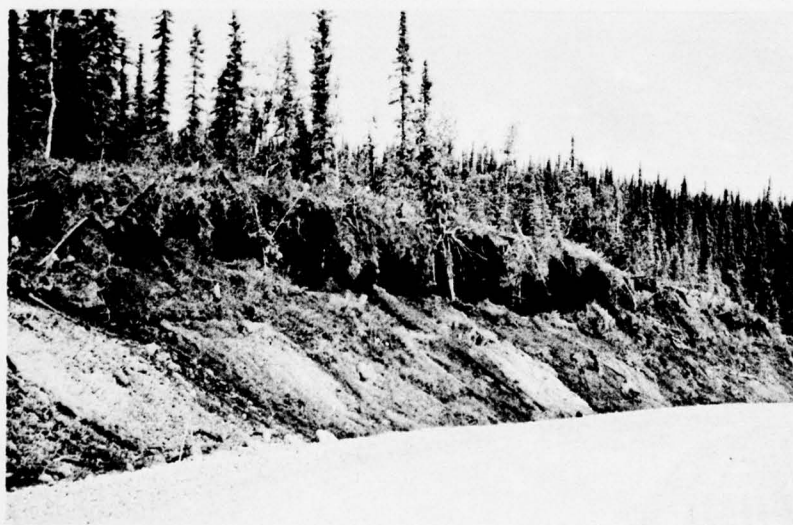
57. Ice face with overhanging mat and hydroseeded lower portion of slope, Mile 20.25 Lf, 11 August 1970.

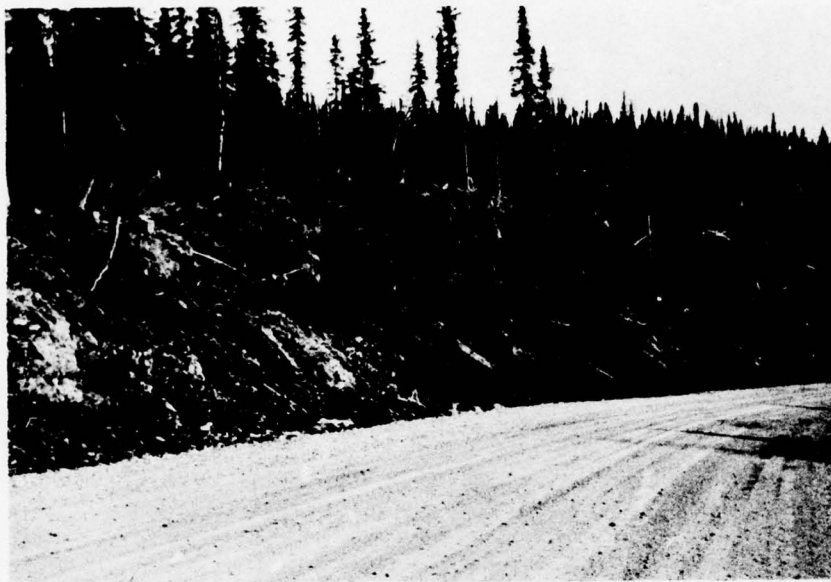
58. Overall view of slope, Mile 20.25 Lf, 28 May 1971.

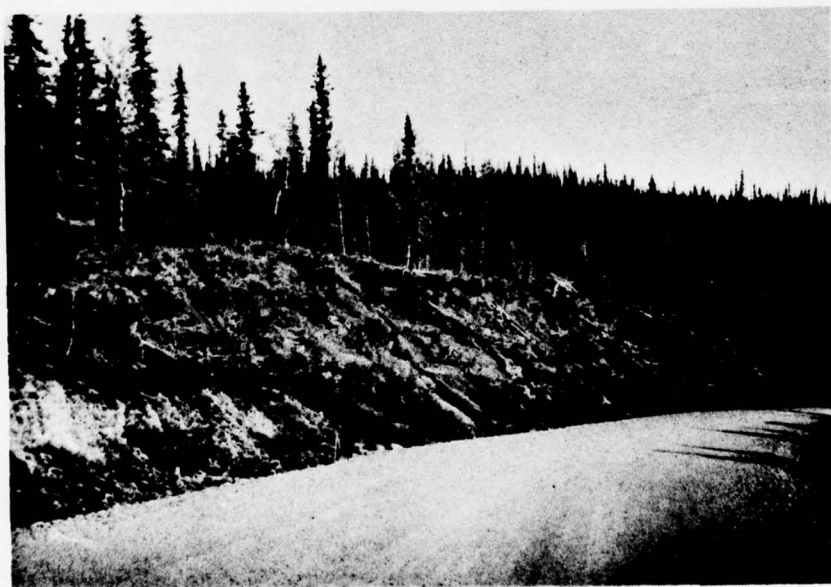
59. Overall view of slope, Mile 20.25 Lf, 17 August 1971.

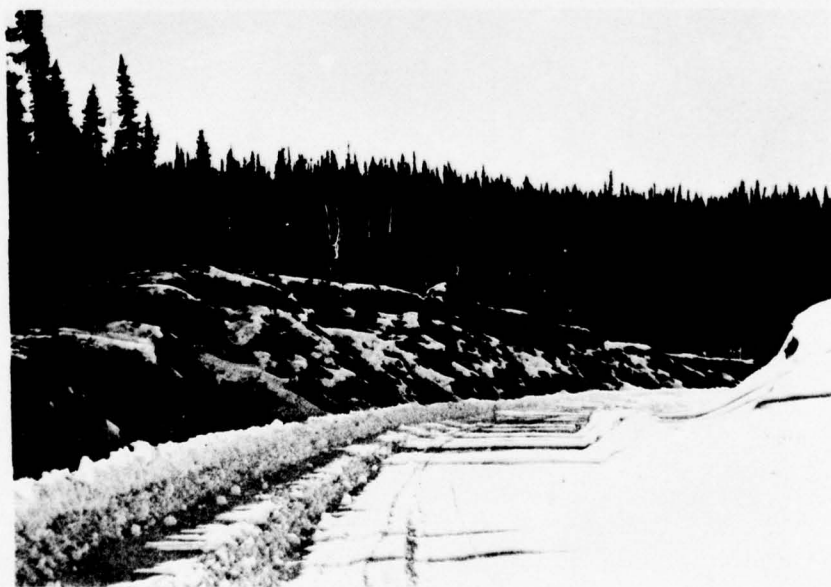
63. Snow covered slope, Mile 20.25 Lf, 20 April 1973.

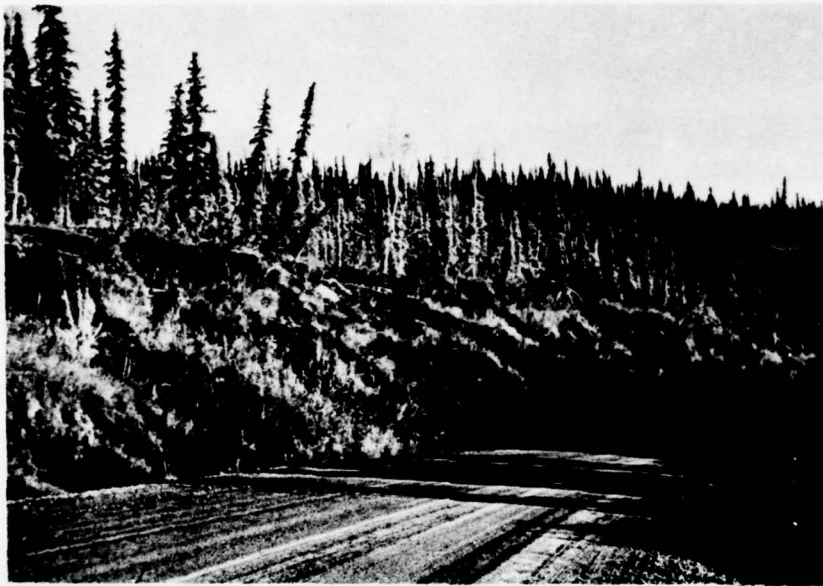
64. Small trees on slope, Mile 20.25 Rt, 27 September 1974.

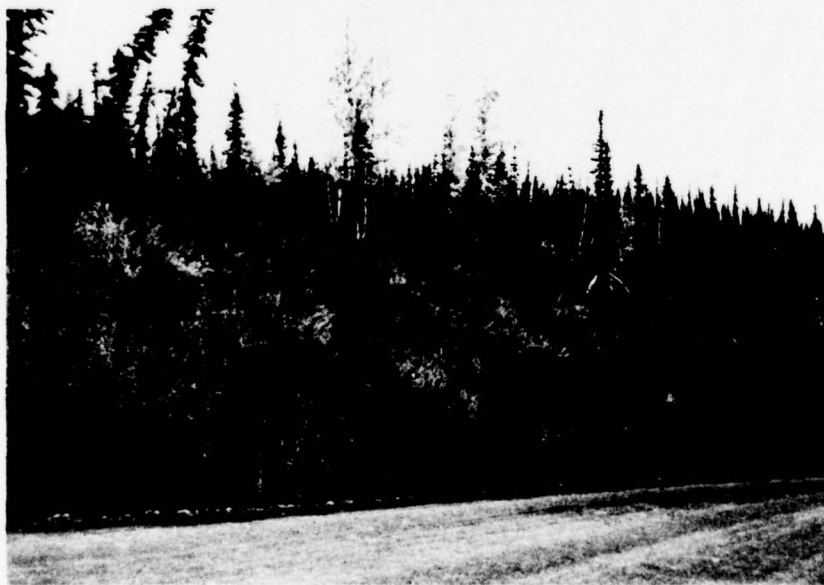
65. Slope covered with small trees, Mile 20.25 Rt, 14 September 1975.

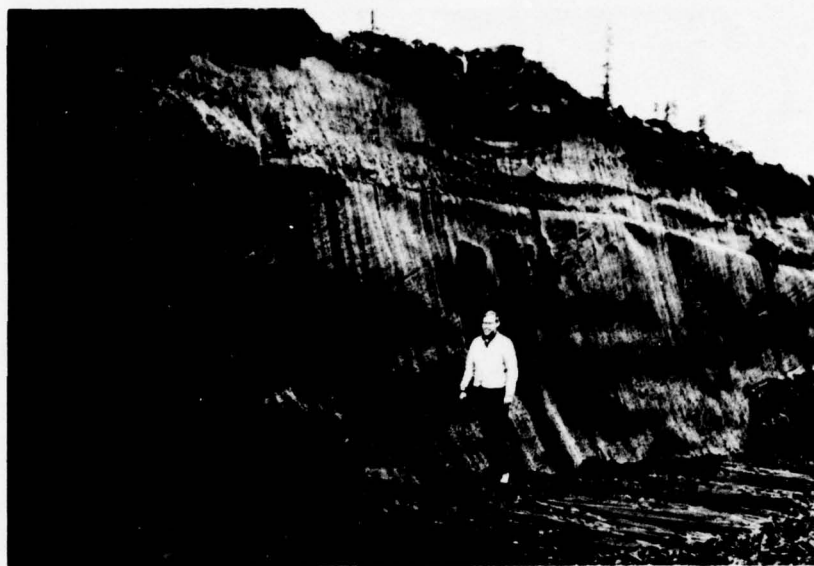
69. Massive ice still visible, Mile 22.9 Lf, 26 June 1970.

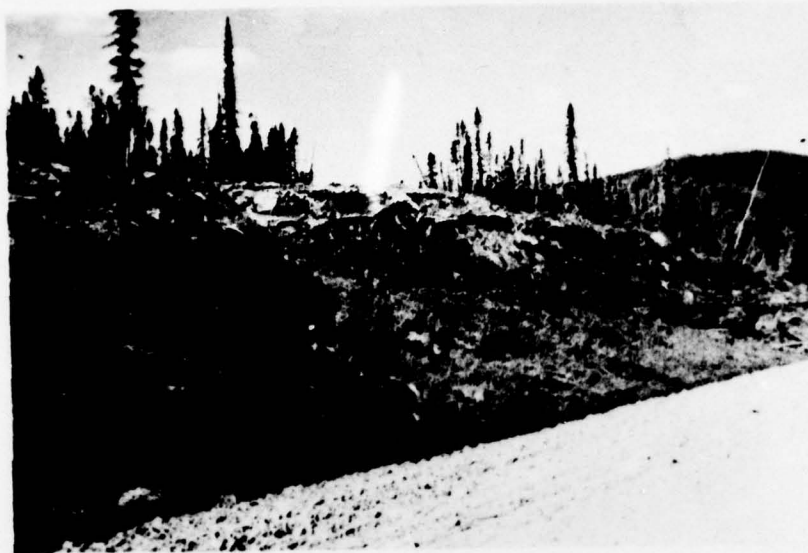
71. Grass not started on portion of backslope, Mile 22.9 Lf, September 1970.

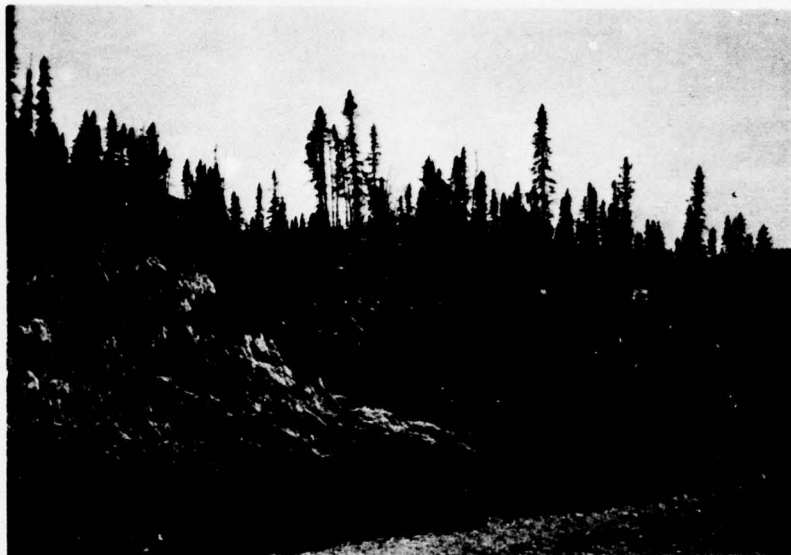
73. Continued instability of backslope, Mile 22.9 Lf, 23 June 1972.

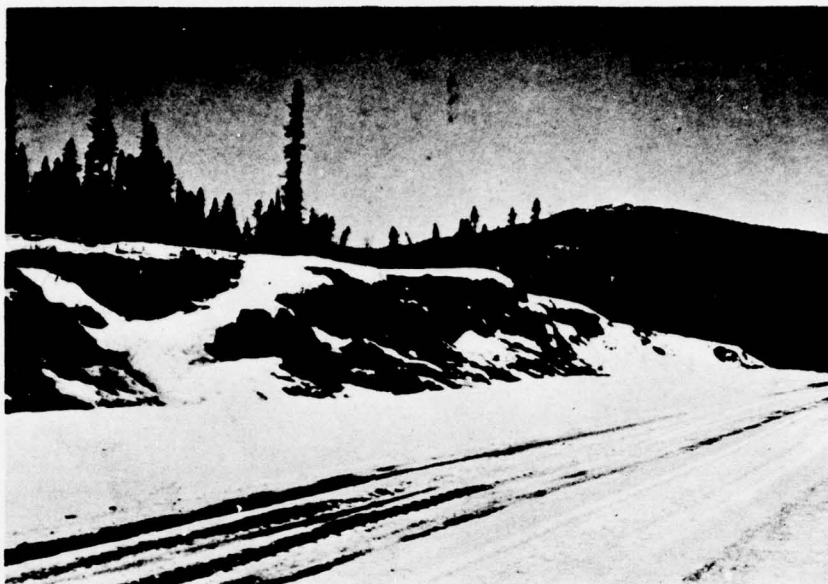
75. Grass-covered slope, Mile 22.9 Lf, 27 September 1974.

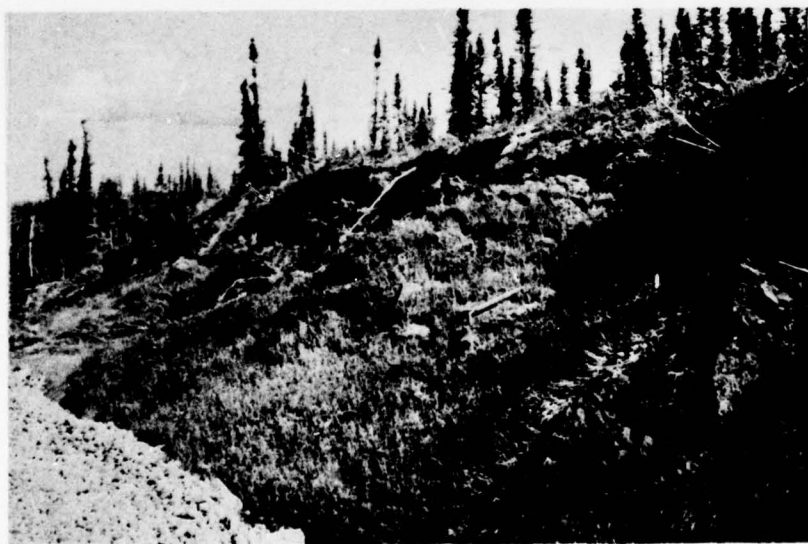
77. Parts of backslope stabilized and other sections receding, Mile 22.9 Rt, 11 August 1970.

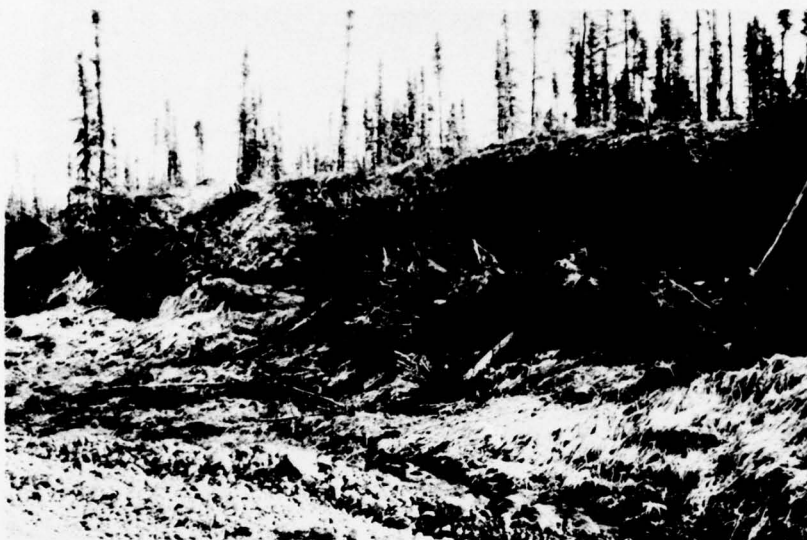
78. Center portion of slope, Mile 22.9 Rt, 28 May 1971.

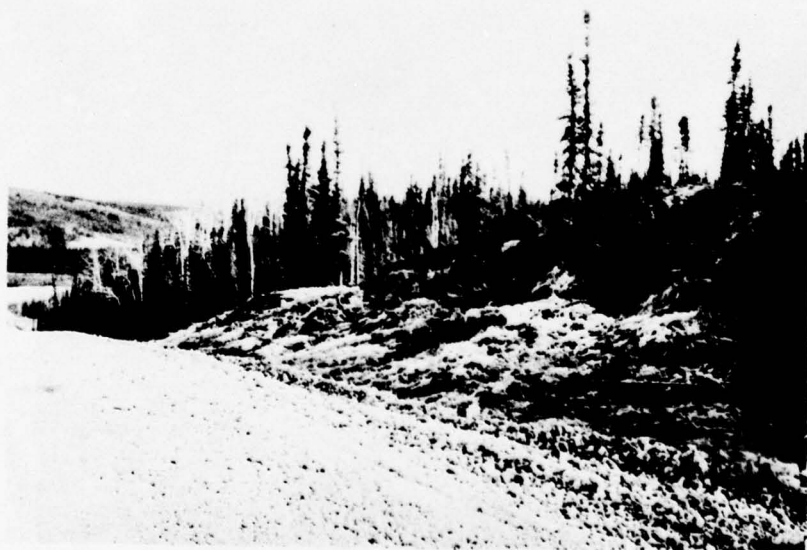
79. Northern portion of slope, Mile 22.9 Rt, 23 June 1972.

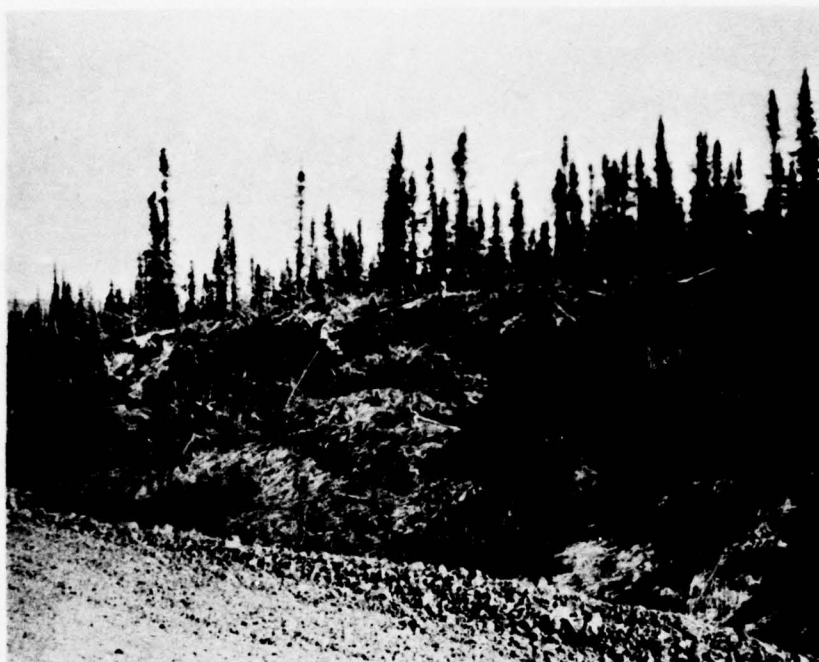
80. Center portion of slope, Mile 22.9 Rt, 17 August 1971.

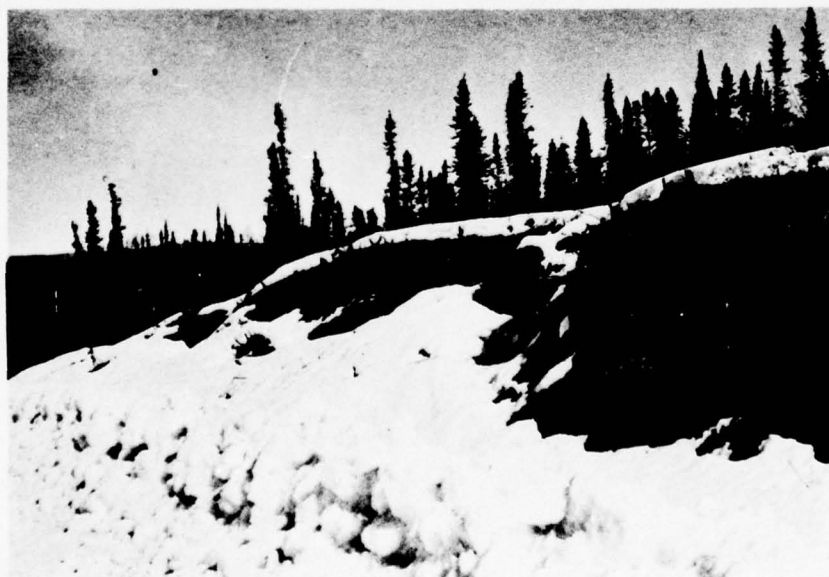
81. Backslope with snow cover, Mile 22.9 Rt, 21 April 1973.

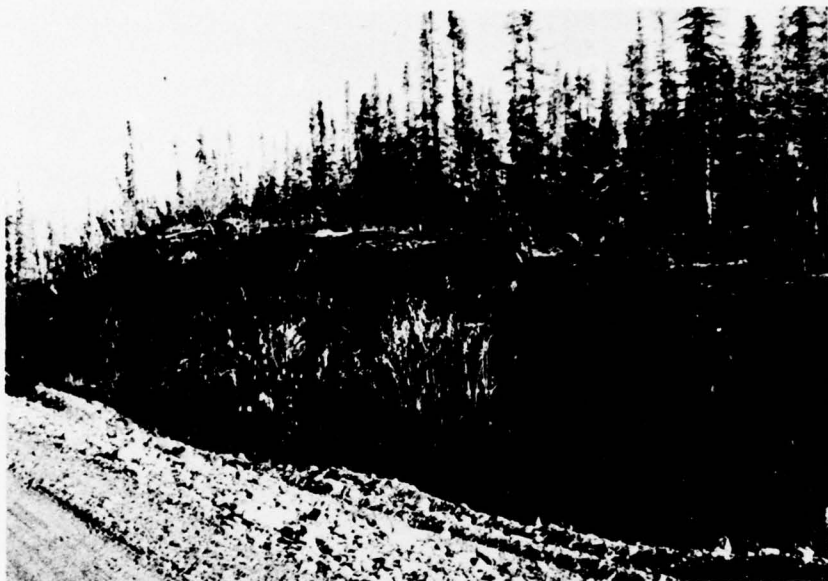
82. Backslope with small amount of grass, Mile 22.9 Rt,
27 September 1974.

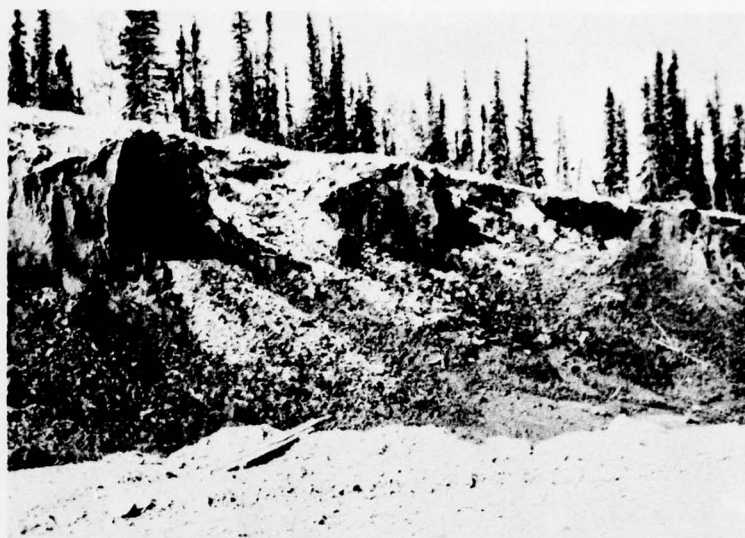
84. Center portion of slope showing fibrous insulation on cleared top of backslope, Mile 23.2 Lf, 11 August 1970.

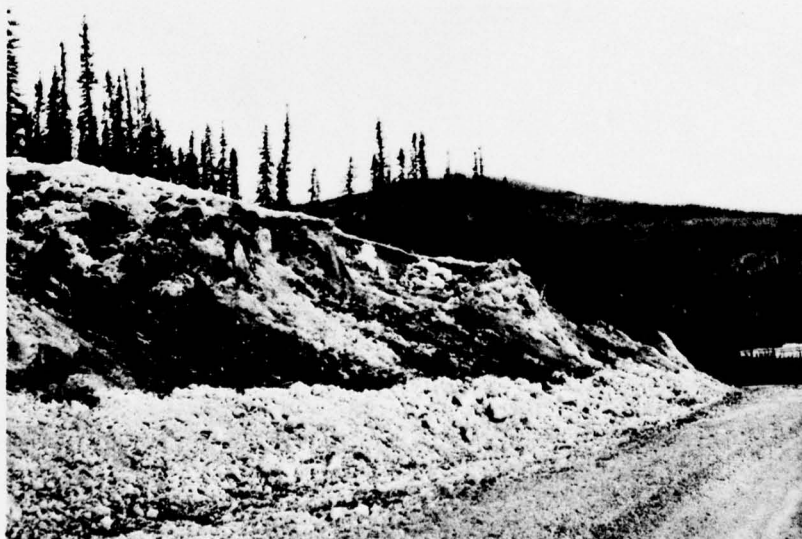
85. Gravel berm near base of backslope, Mile 23.2 Lf, 28 May 1971.

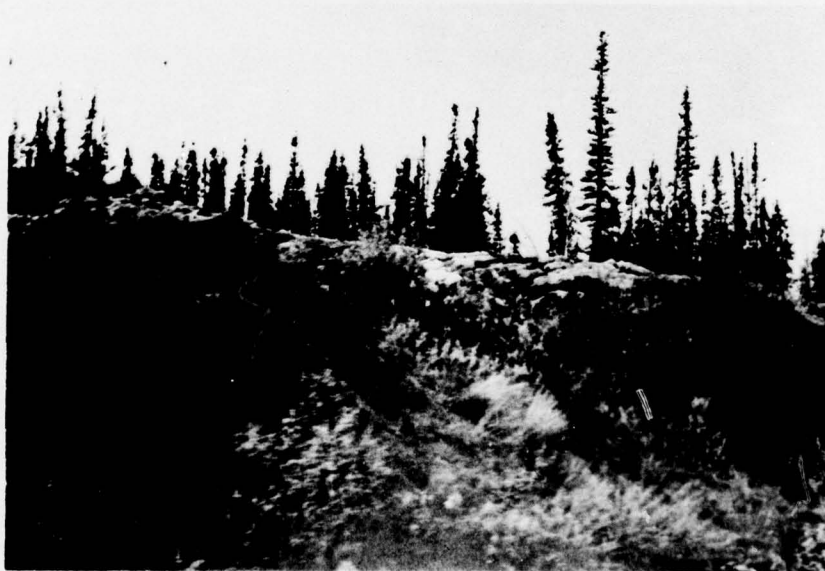
89. Grasses and small trees on backslope, Mile 23.2 Lf, 14 September 1975.

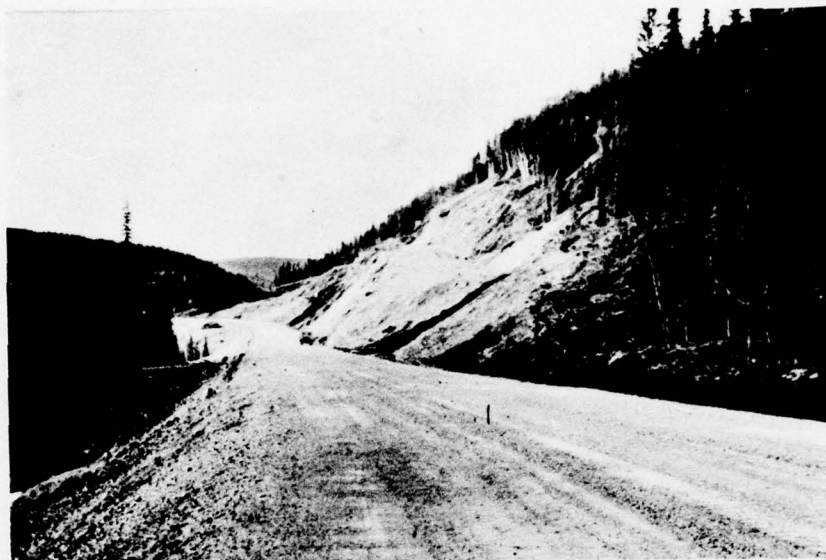
90. Overall view of backslopes, Mile 33.1 Rt in foreground and Mile 33.3 Rt in background, 26 June 1970.

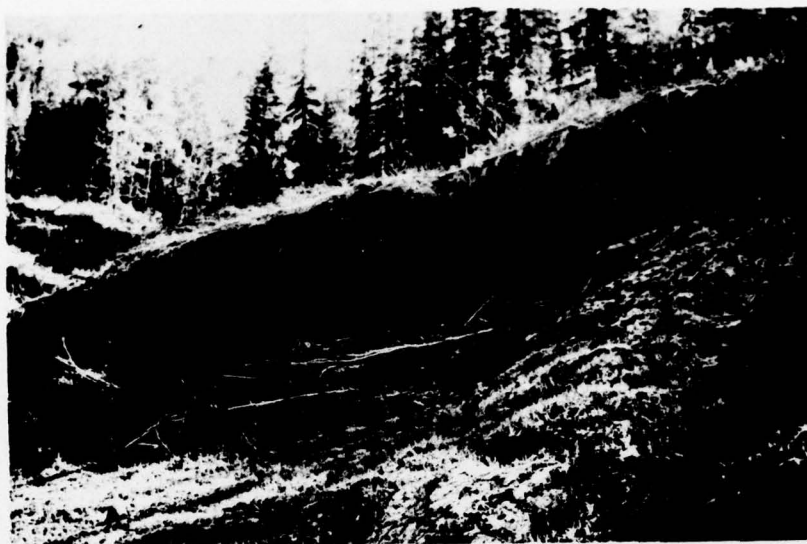
92. Ice-rich backslope, Mile 33.1 Rt, 11 August 1970.

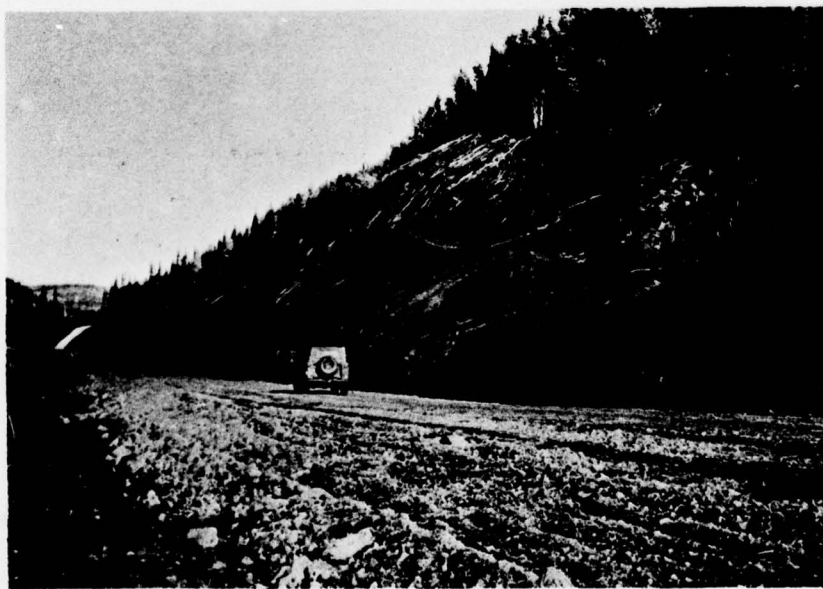
93. Overall view of backslopes, Mile 33.1 and 33.3 Rt, September 1970.

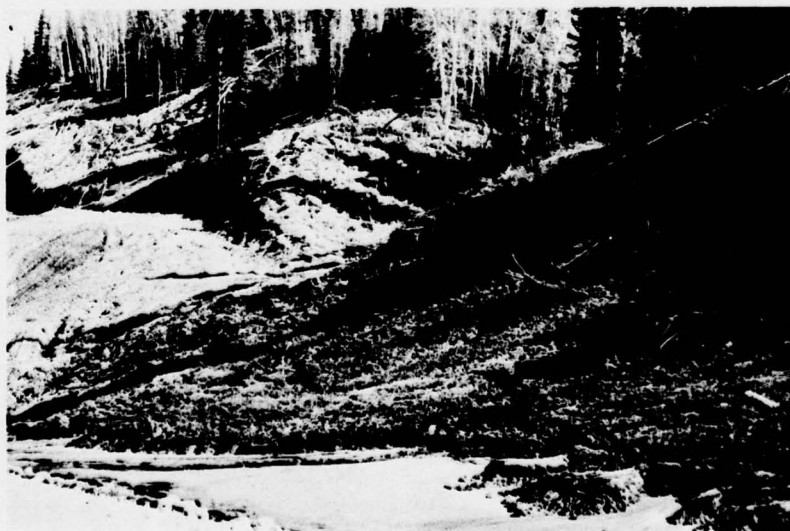
95. Northern end of slope, Mile 33.1 Rt, 28 May 1971.

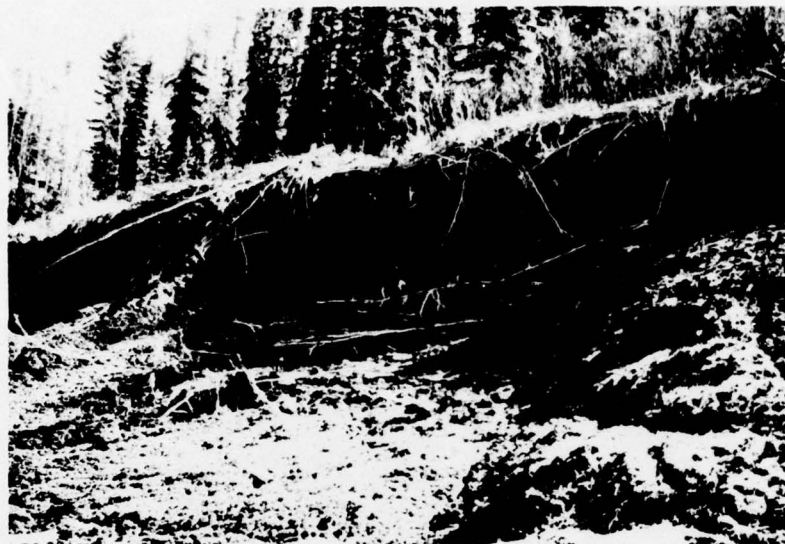
96. Center portion of slope with mat overhanging ice face, Mile 33.1 Rt, 28 May 1971.

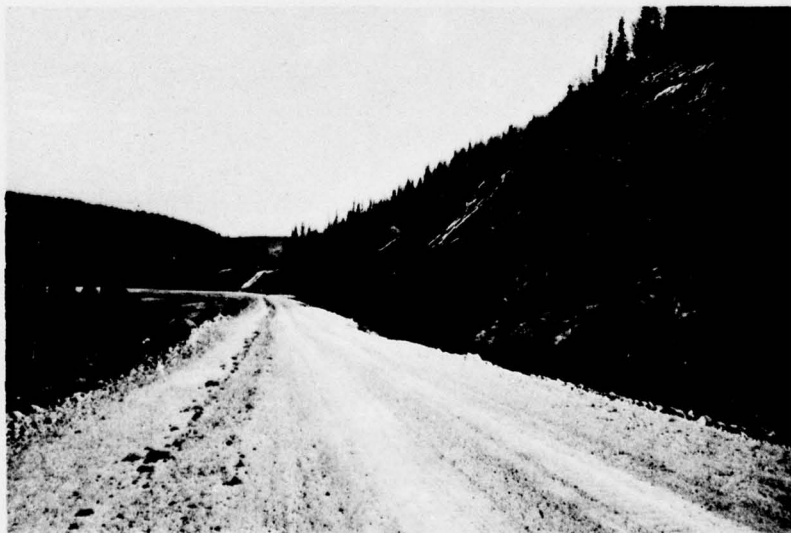
97. Benched slope, Mile 33.3 Rt, 28 May 1971.
